Disaster Management Course

General Field Work Report – Fellows’ Project

May 2016

Jericho Palestine

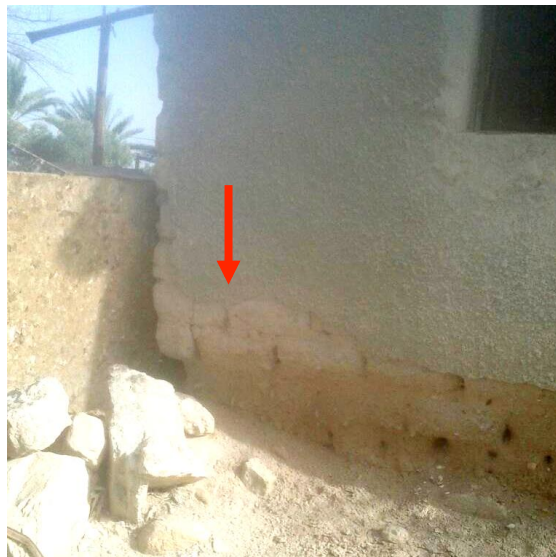
The old house is made half in concrete and half from mud bricks as in figure (1) and wooden roof as in figure (2). It is very week to earthquakes and suffers from damage every winter. No authority provides support in case of damage.

Figure (1): Traditional construction in Jericho of mud-brick building.

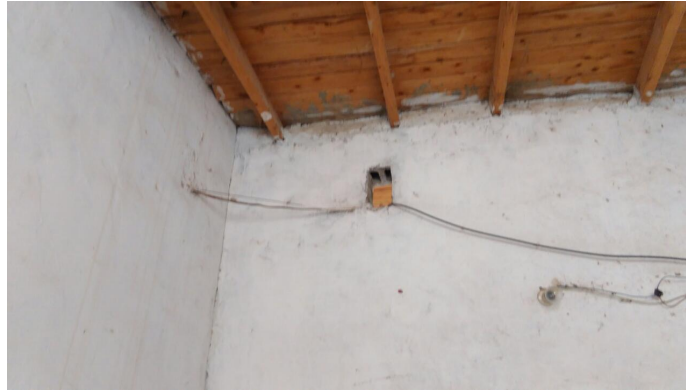
Figure (2): Weak wooden roof, prone to leaking of water during rainfall.

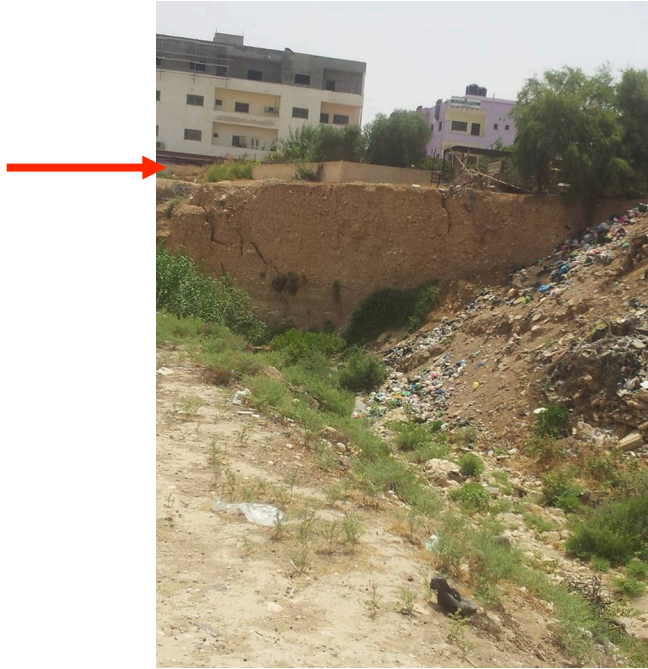
This house is build directly on the streams way as in figure (3), the land has been licensed by the Municipality although it is very clear that its location is very dangerous in case of flash floods. The house is quit new 6-7 years old, however it doesn't have any earthquake proof design in its building. The furniture of the house is secured well to the walls.

Figure (3): Outer garden wall of the house directly on the edge of the Wadi.

1- Since multiple houses are located on the flank of the stream, it is recommended that the municipality, with the help of the people, build a retention wall on the flanks to minimize the damage caused by the floods on their house.

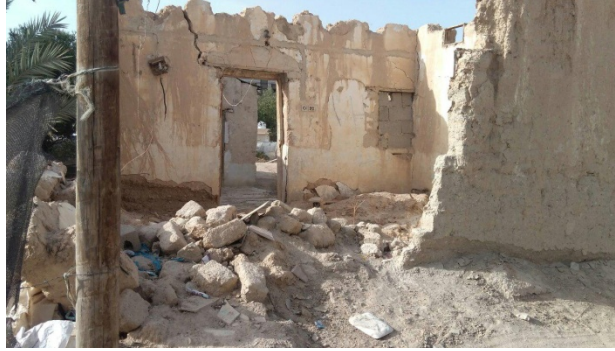
He witnessed the flood destroying the small bridges, the old houses and the walls of the fence. And the water ran to the lower land. The houses affected were mostly uninhabited as shown in figure (4), however the children panicked to the sight. This episode happened in the 70s. Mr. Abu Dahuk has helped many during flooding disasters.

Figure (4): we structures that are easily affected by natural disasters.

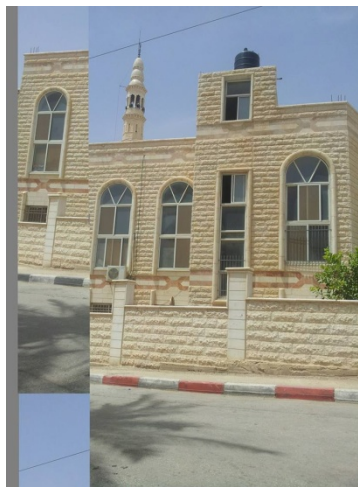
The Mosque has been recently rebuilt according to the standards of safety. Since it was rebuilt, it has not suffered from flooding or earthquakes.

It would be an ideal location for a field hospital or for receiving refugees as in figure (5).

Figure (5): The Mosque's solid structure.

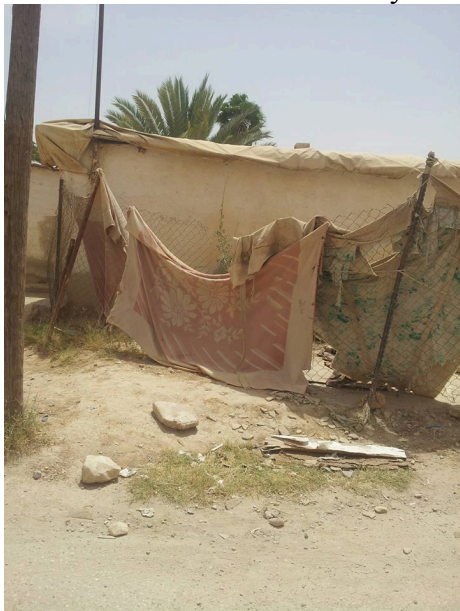
The study made in the Jericho area revealed some serious issues in lack of knowledge and preparedness of the residence in cases of natural hazards. There are multiple houses in danger zones of flooding and many buildings are very weak and cannot resist earthquakes as in figures (6) and (7). There are several locations that can be fit as emergency ground for field hospitals or refugees reallocation like the Mosques, School playgrounds, the public transportation parking and the churches inner parks. A lot of people showed good will to help others in distress and several candidates for Monitor position have been pointed out. Serious planning has to be made in order to make this area ready for emergency situations starting with awareness campaigns.

Figure (6): Old buildings

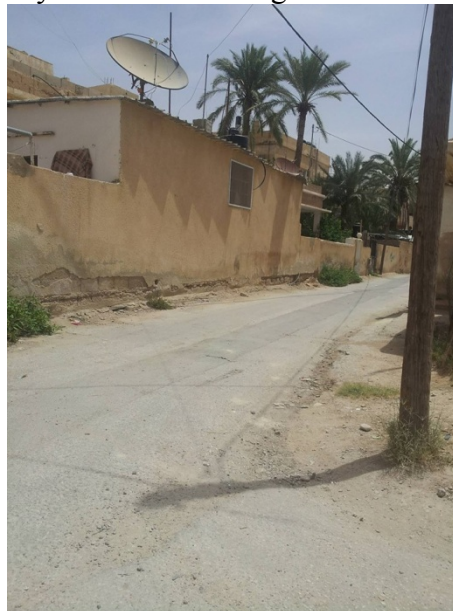
figure (7): Low quality building

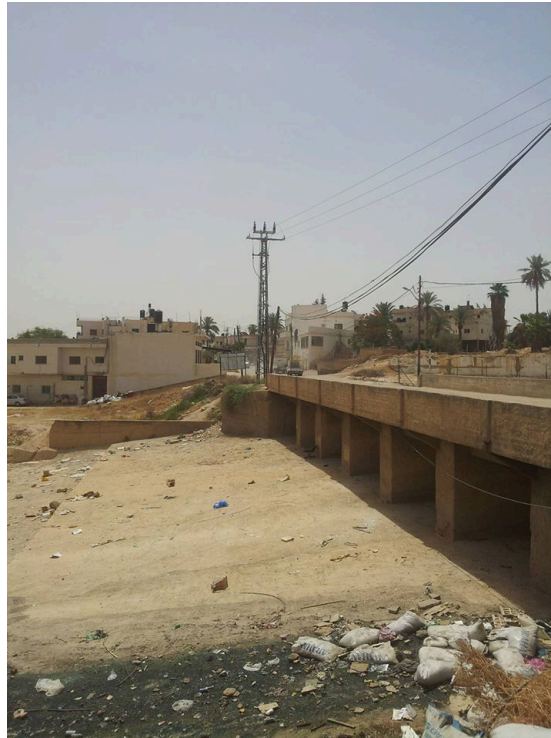
Figure (8): The damaged pillars of the bridge.

- 4- The building of a new hospital in the northern part of the city that can serve the people in cases of emergency since the sole existing hospital in Jericho is geographically separated and hard to access during hazards.
- 5- It is also suggested to start planning on using the Mosque, Churches and large parking space as emergency fields in case of hazards.
- 6- It is also suggested to start planning on using the Abbasi Mosque in Aqbat Jaber refugee camp as emergency location in case of hazards.
- 7- Reconstruction (or renovation) of the bridge over the stream since it has been damaged by floods before and has quit week pillars against future floods as in figure (8).
